DETAILED SITE INVESTIGATION

297 TE PUNA STATION ROAD,
TE PUNA, TAURANGA

Prepared For: Momentum Planning and Design Limited

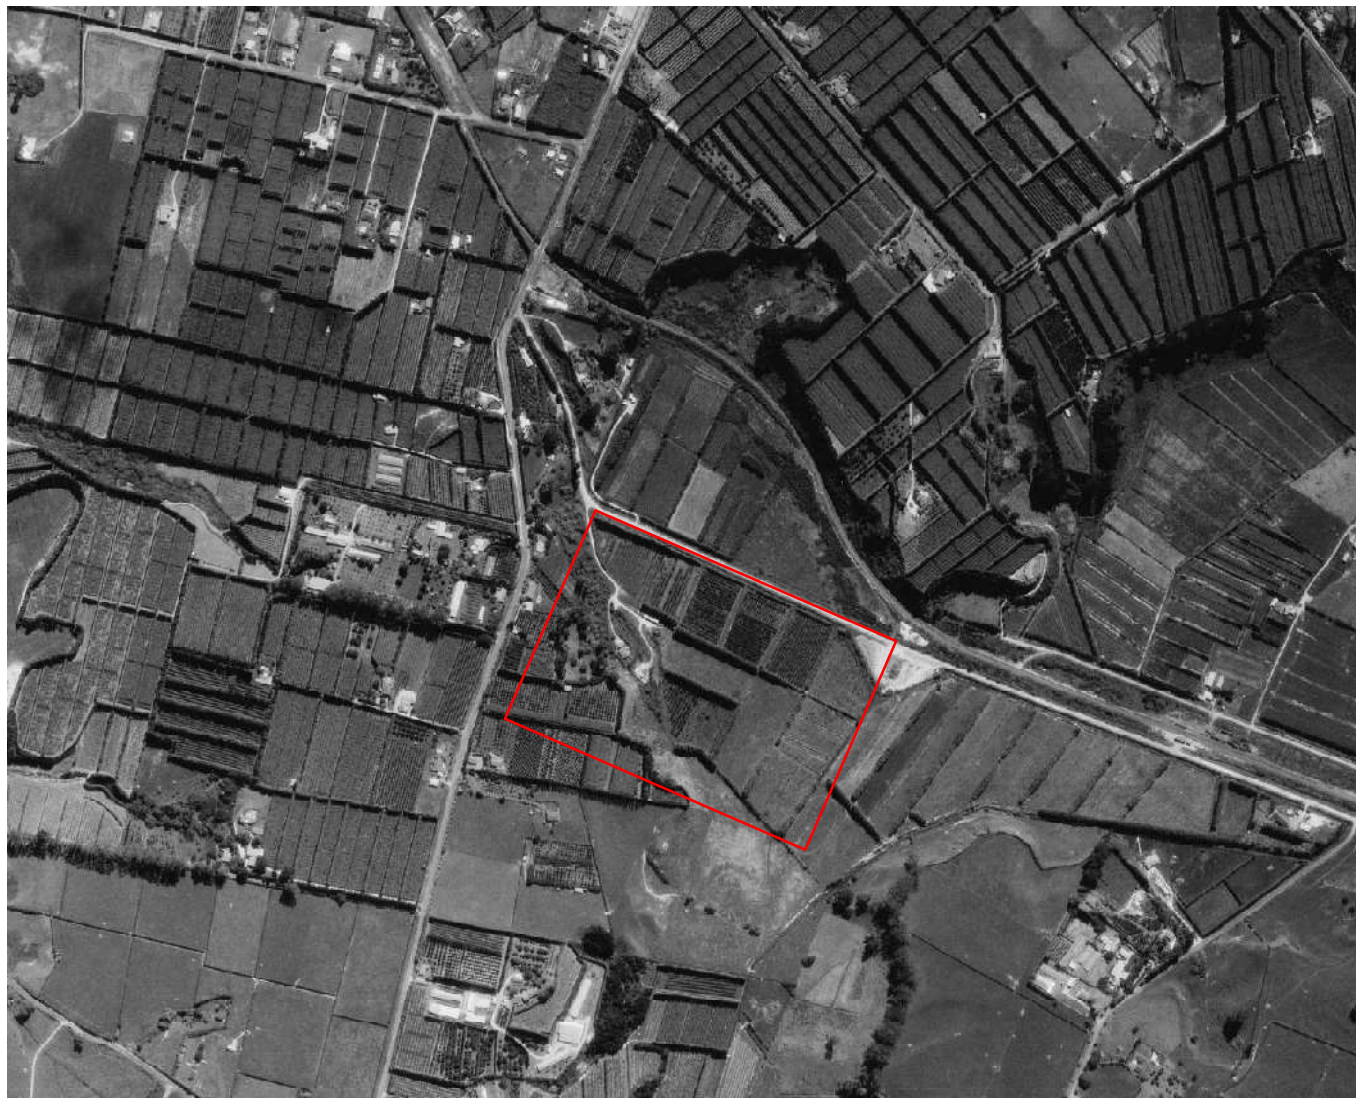
1986 (cropped)

1986	Approximately half of the property appears to be in orchards (northern paddocks and two southern paddocks). The remainder is in pasture land. Some of the pasture land appeared to have been converted back into pasture after having been planted out into orchards from what could be observed of the site in the 1981 photo. There are two additional areas that have been cleared on the site. One is at the location of the current house and is likely the site of the house that was relocated to the site in 1977. The other cleared area to the east of house site also appears to have a building sited there.	Surrounding area is largely in orchards. There is some pasture land remaining on the adjacent properties to the south and southeast of the site. The property directly north of the site has been put into orchard.
1992	Site looks unchanged	Surrounding area looks unchanged. The property to the north of the site, across the road appears to have been cleared of orchard and is being returned to pasture land.
