Project Number: 2-9Z729.01

# Te Puna Container Co 297 Te Puna Station Road

2 December 2022

## Geotechnical Assessment Report

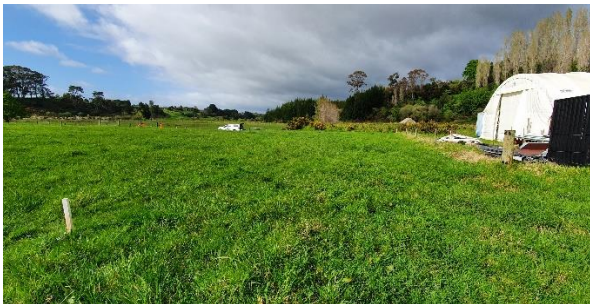
*Photo 5 Looking towards the current landscape yard*

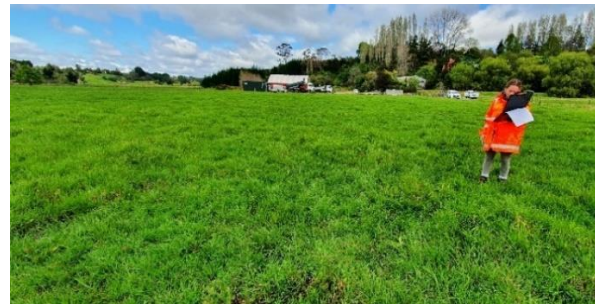
*Photo 6 looking south towards landscape yard*

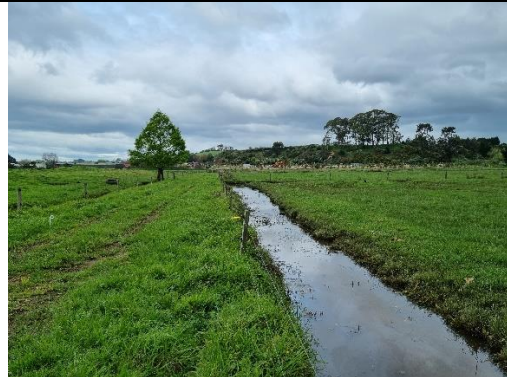
*Photo 10 open stormwater drain looking east*

Several open stormwater drains were observed extending through and nearby to the site. This includes open drains running east-west along the northern and southern boundaries of Te Puna Station Road, as well as open drains running north-south and east-west through the site itself. Groundwater appeared to be situated at an elevation of approximately RL 1.5m in the open drains. Several natural and potentially man-made ponds were also observed in the northern portion of the site. We understand that the site is prone to flooding following periods of heavy and prolonged rain.

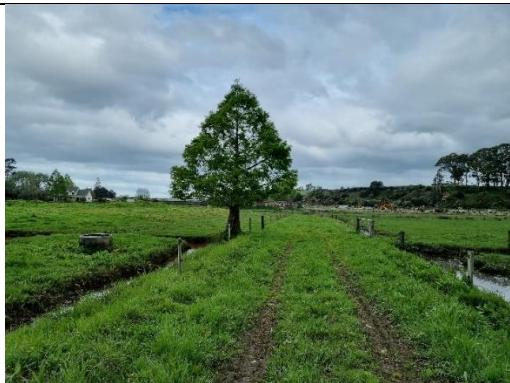
*Photo 11 stormwater drains either side of track looking east*

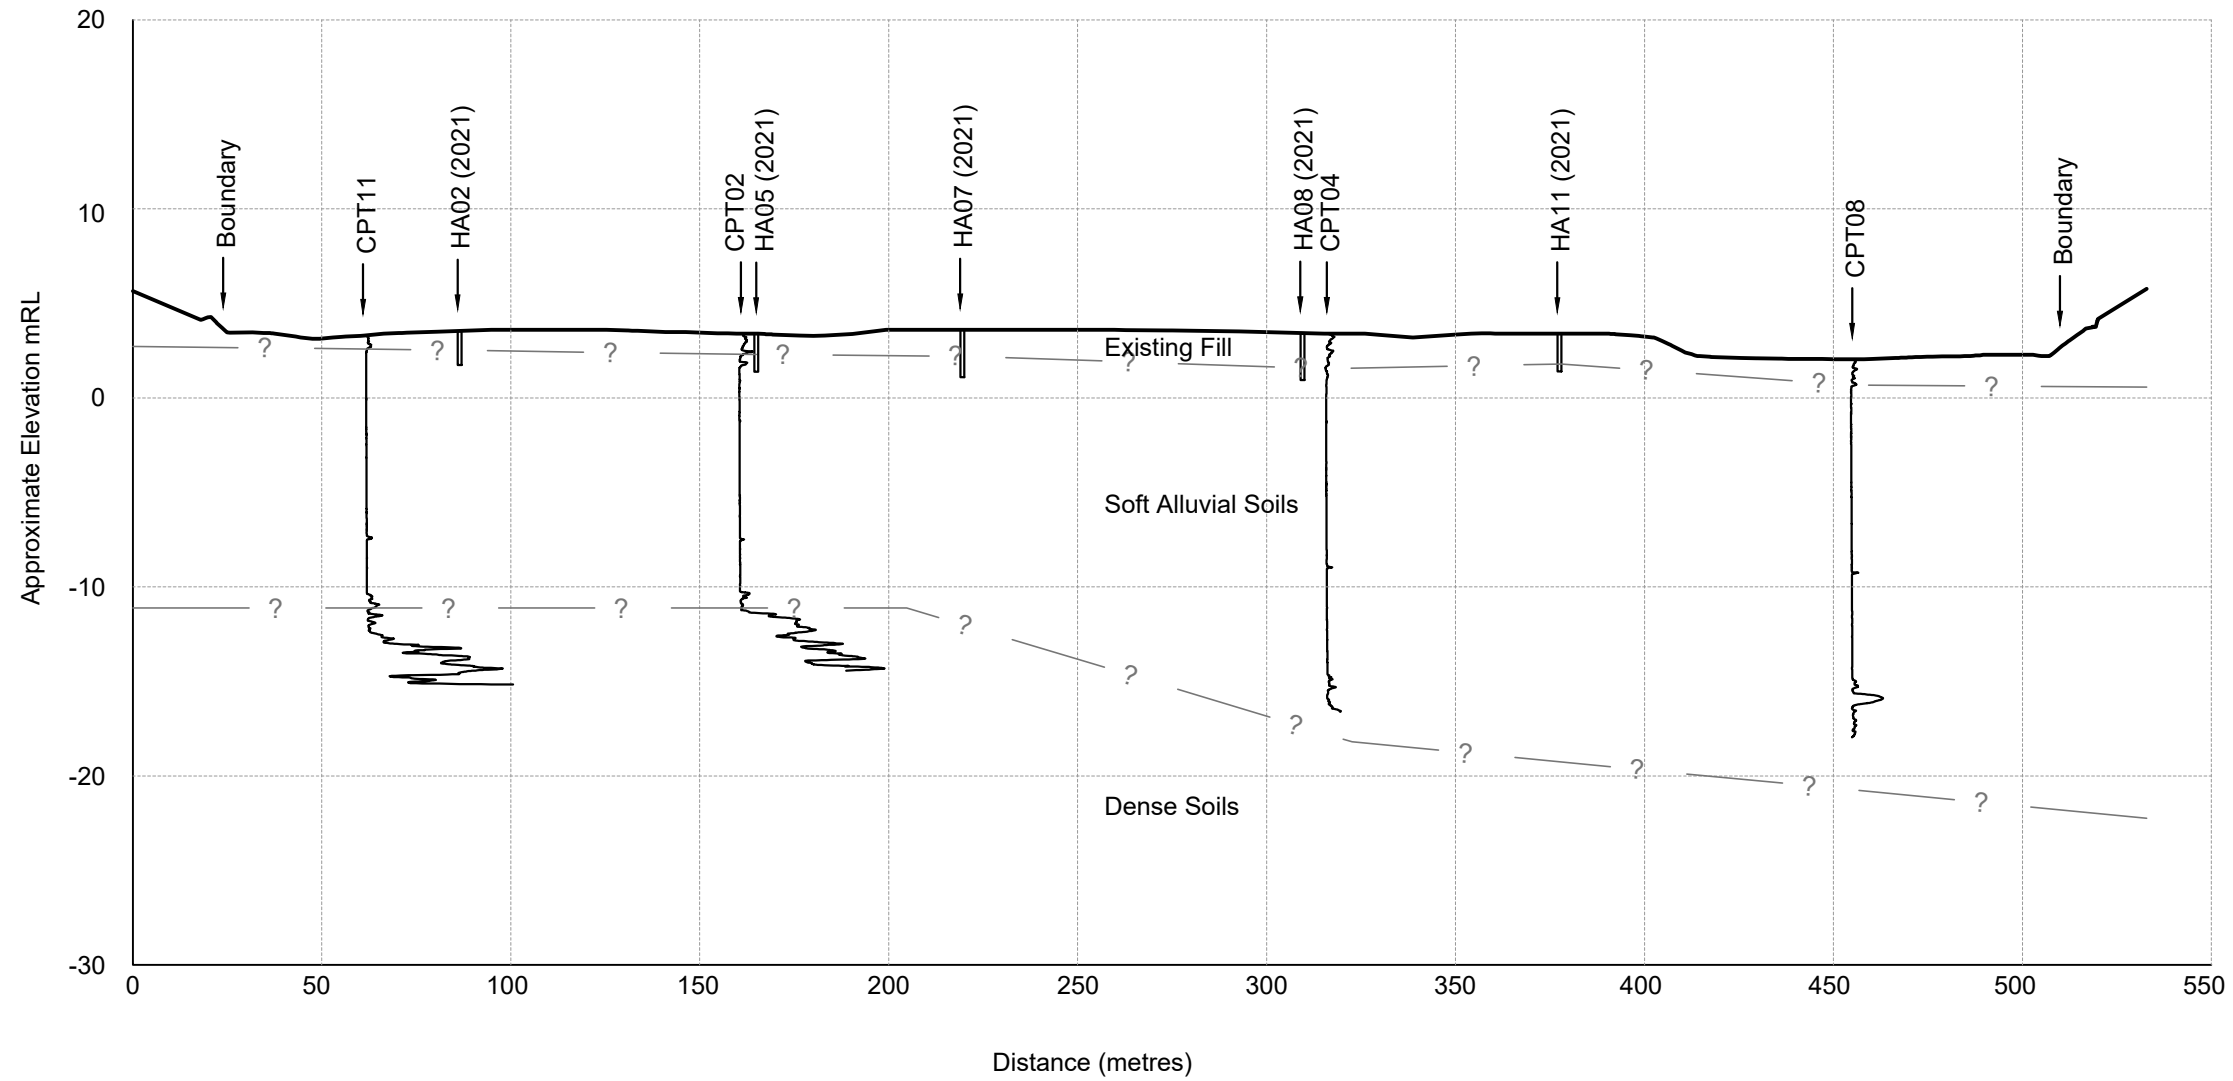
## CROSS SECTION B-B

LEGEND	
	INFERRED GEOLOGICAL BOUNDARY
	HAND AUGER BOREHOLE
	CPT QC TRACE
